NATIONAL TRANSPORTATION SAFETY BOARD

SPECIAL INVESTIGATION REPORT

TANK CAR STRUCTURAL INTEGRITY AFTER DERAILMENT

NTSB-SIR-80-1

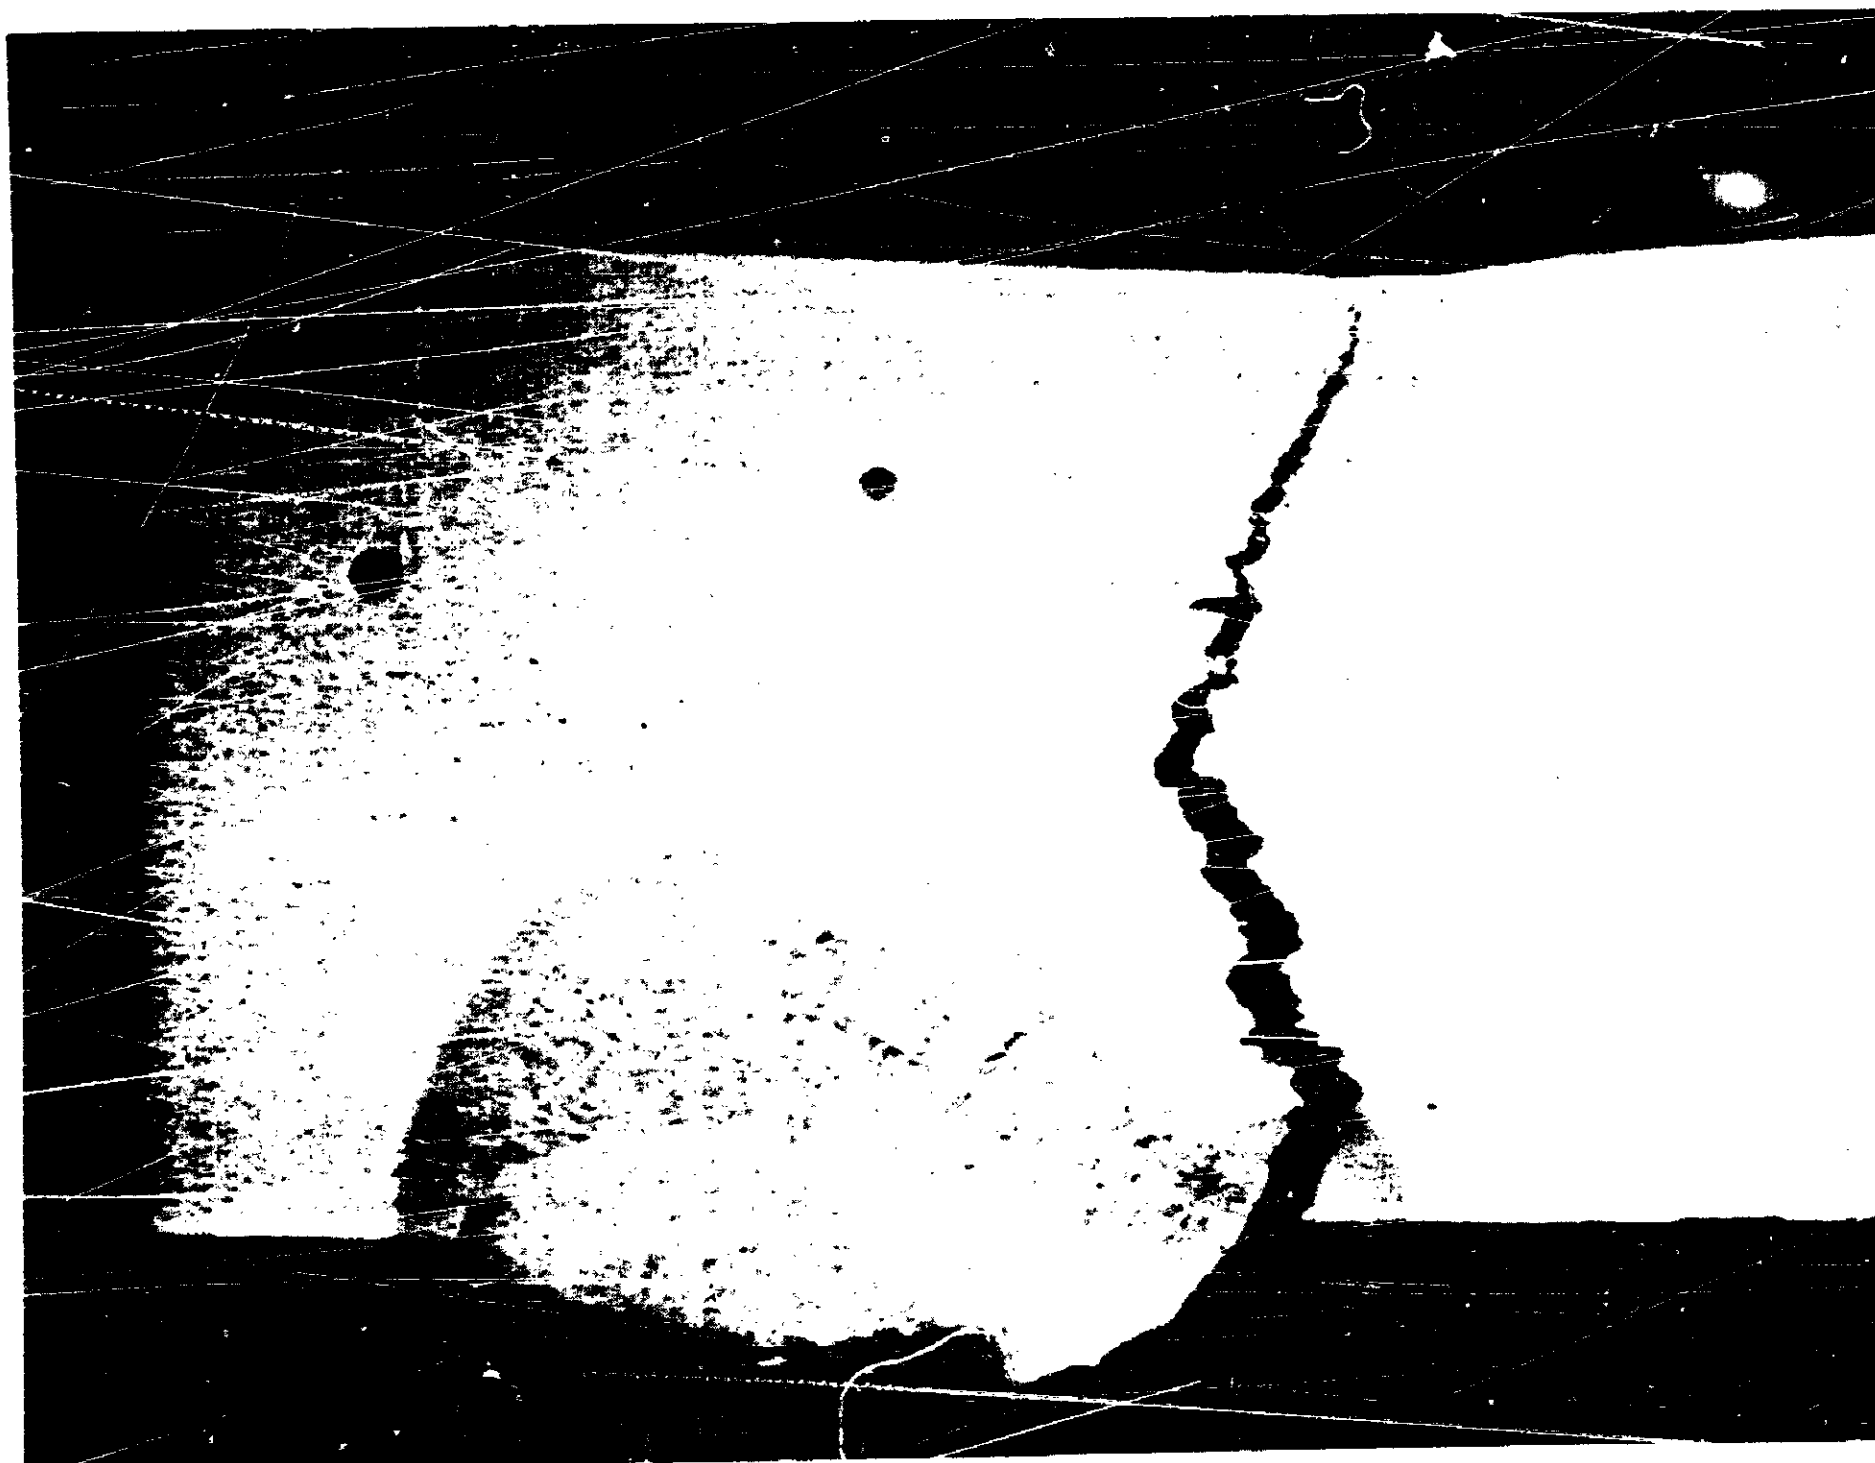
The fracture extended from the heat-affected zone (HAZ) ^{8/} of the fillet weld to the tank base metal in the immediate vicinity of the bolster structural support. The combination of reduced toughness (as indicated by increased hardness in the HAZ) and the formation of a "hinge" at the bolster structural support caused the tank to fail at this point. The tank fracture was a completely ductile failure. (See figure 8 and appendix C.)

Figure 8.--Cross section of rupture showing origin of crack in the heat affected zone of the attachment weld.

Another area of concern is the welded attachments to the tank. The attachments are needed to make the tank into a vehicle. Since the failure of GATX 26024 occurred as the result of an attachment weld, this indicates that derailment damages to tank attachments need further examination. Further testing of damaged tanks may identify other areas which may require remedial actions.

Examine ruptured tank cars to determine what effect current design and welding practices for welded tank attachments may have on the structural integrity of tank car loaded with pressurized liquefied gases in the derailment environment, and report the resultant findings. (Class II, Priority Action) (I-80-3)

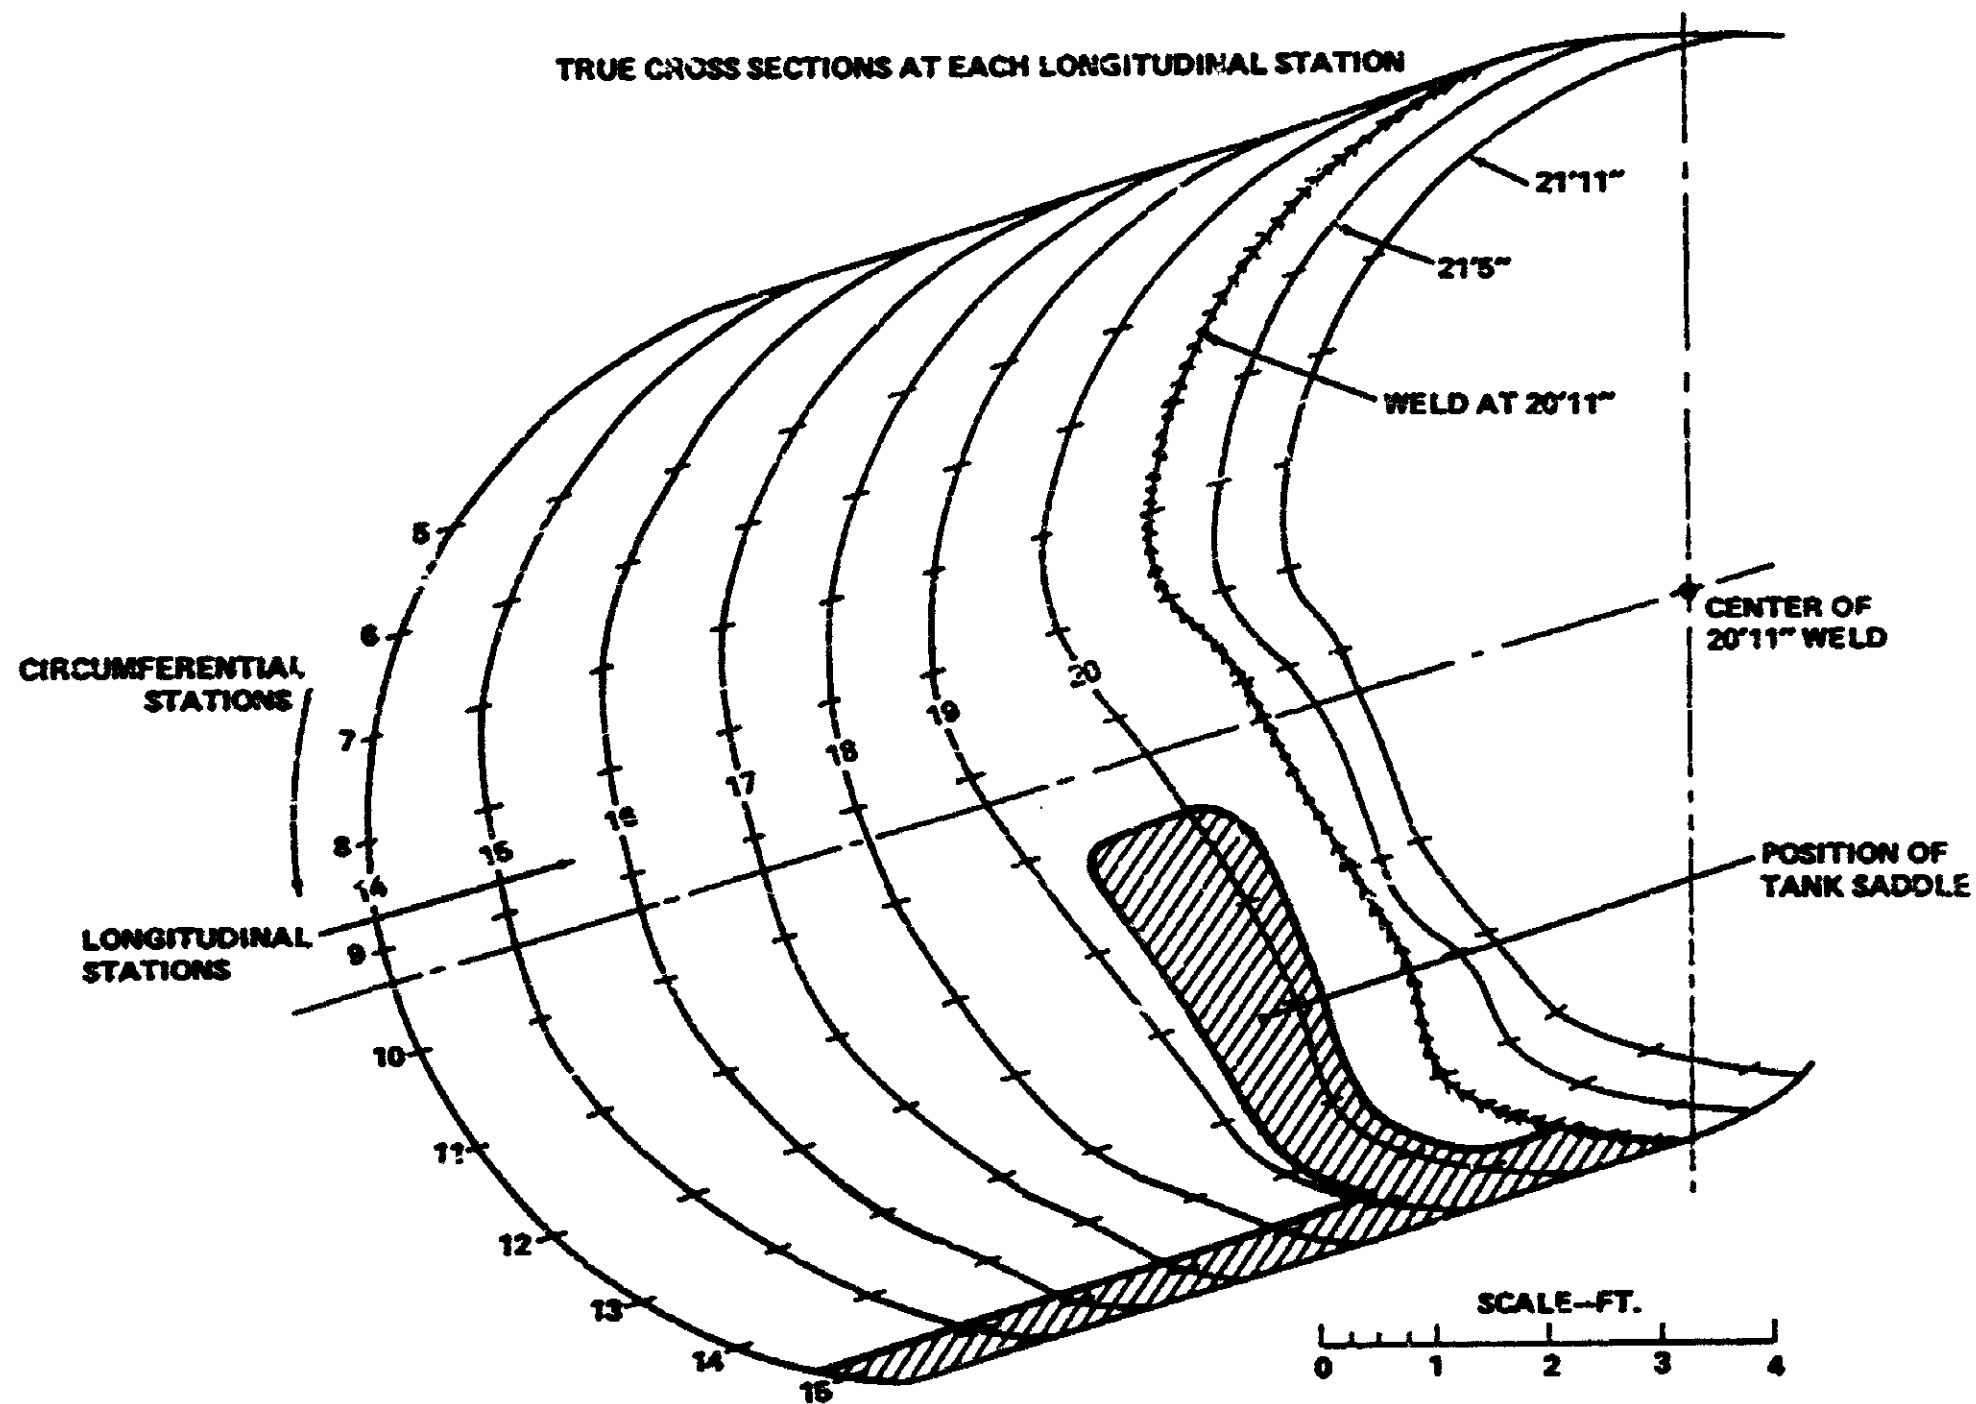
(2) Changes in Tank Deformation During Pressure Test.--After 24 minutes of operation, the pump was shutdown because it was not pumping sufficient volume at the low pressures. At this point, water main pressure of 75 to 80 psi was used to continue the test. About 47 minutes after the start of the test, the pressure was reduced to 0 psi, and permanent deformation of the tank shell was noted. Subsequently, line pressure was reapplied for 1 hour 23 minutes and the dent continued to deflect and more nearly assume the original tank contour. After 2 hours 52 minutes, a large portion of the dent had been displaced outward to approximately the original shape, the pump was started, and the internal pressure was increased. After 3 hours 19 minutes, the tank ruptured at 205 psi. The pressure decreased immediately, and no propagation of the rupture was noted. The tank ruptured in the weld between the left side of the saddle plate and the tank, near the stub sill reinforcing plate. (See figure 6.) Dent dimensions were recorded using the same method used before pressurization. (See appendix B.)

DENT GEOMETRY DATA - AFTER PRESSURE TEST
